Photo 1. 12-22-10 GH Dairy #1. View looking east from Grove Avenue. Spillway is in west berm along Grove Avenue. Discharge flows south (left to right) on Grove.

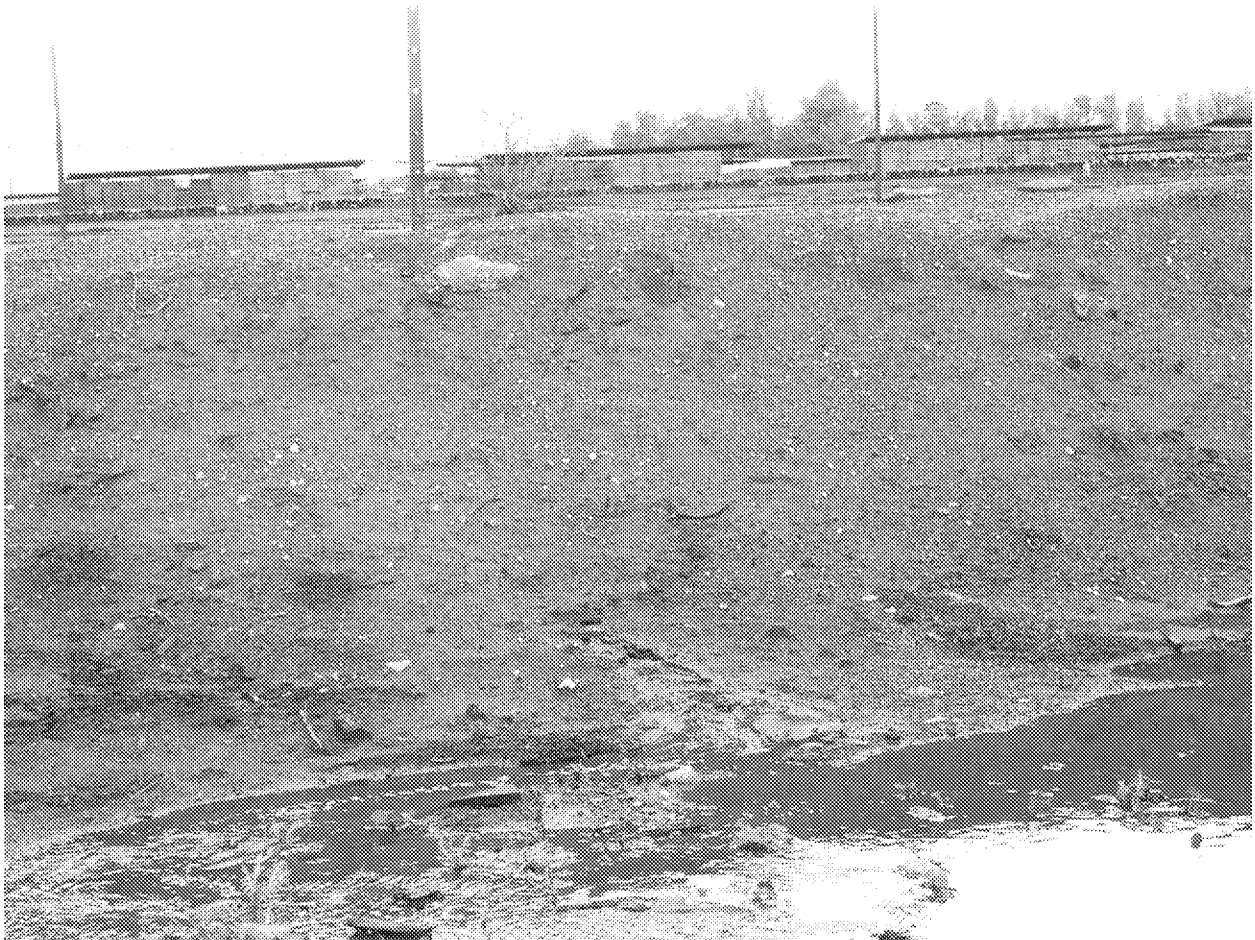
Photo 2. 12-22-10 GH Dairy #1. View looking north from Merrill Avenue. View of south berm along Merrill Avenue. Discharge from rodent hole. Discharge flows west (right to left) on Merrill

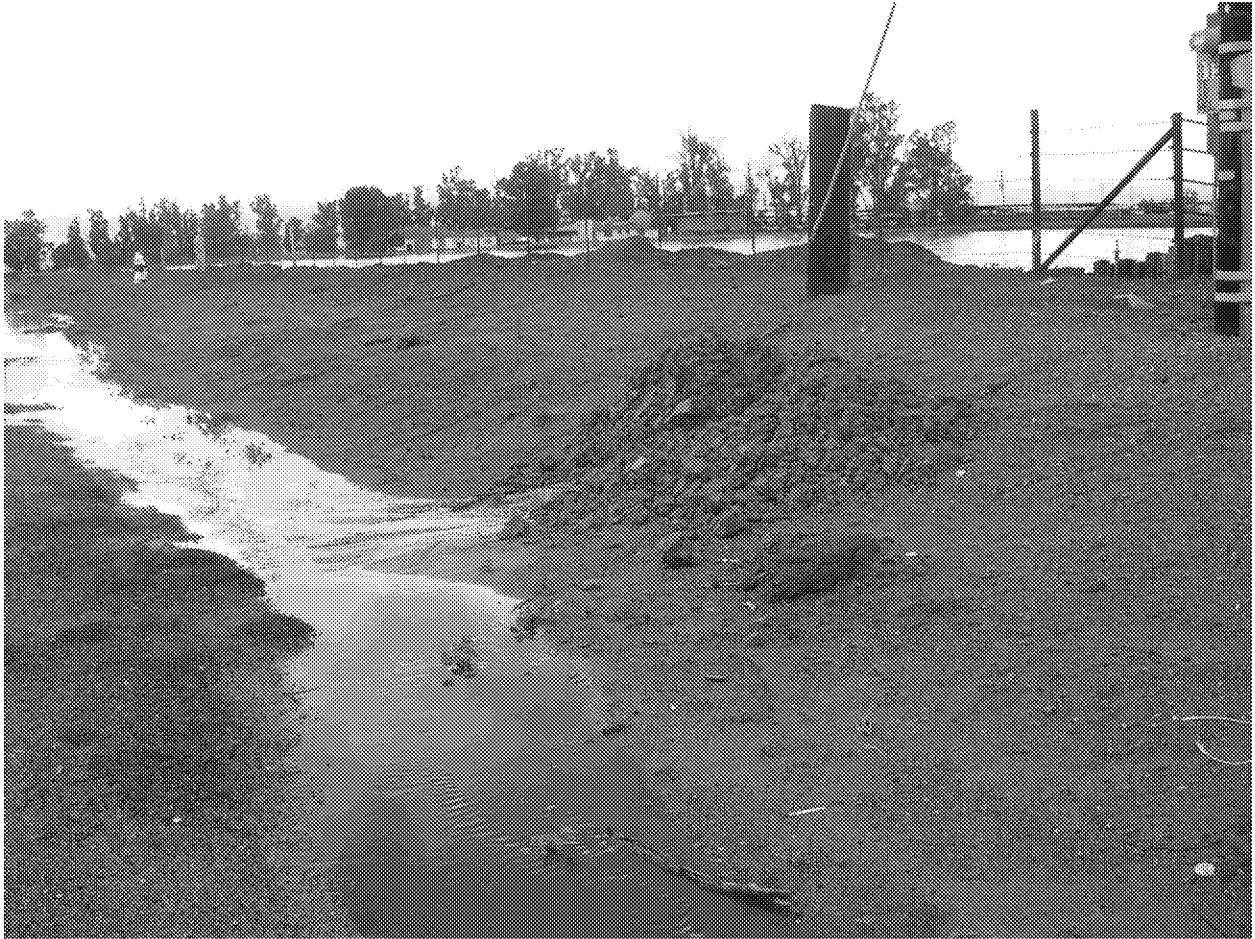
Photo 2. 12-22-10 GH Dairy #1. View looking west from Merrill Avenue. View of south berm along Merrill Avenue. Discharge from rodent hole. Discharge flows west (lower center to upper left) on Merrill

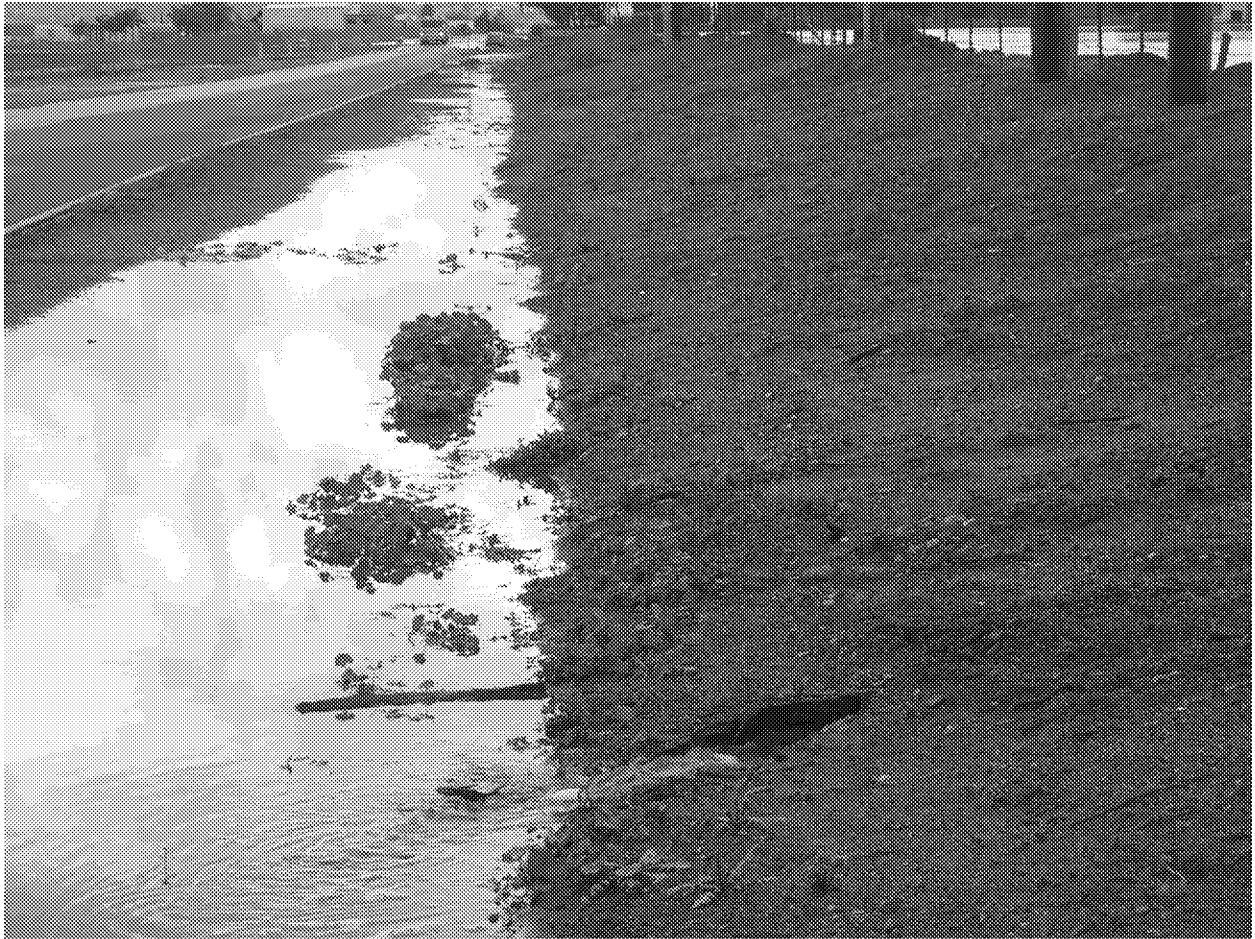
Photo 2. 12-22-10 GH Dairy #1. View looking west from Merrill Avenue. View of south berm along Merrill Avenue. Discharge from rodent hole. Discharge flows west (lower left to top) on Merrill

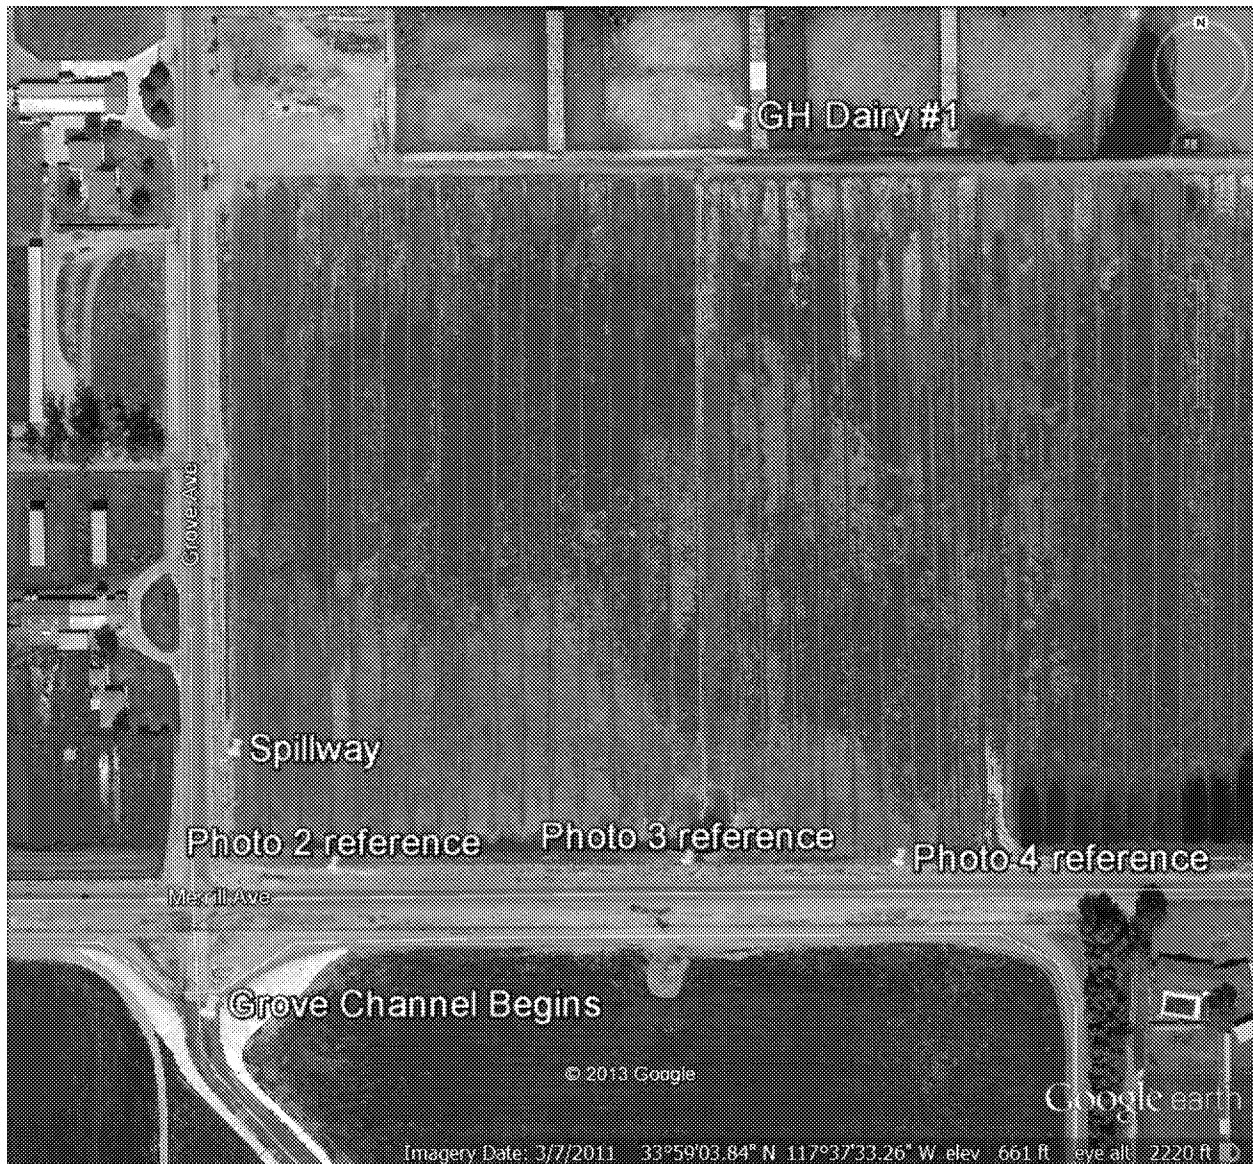
GH Dairy #1. Google Earth satellite imagery with discharge locations.
